INDOOR AIR QUALITY ASSESSMENT

**Milford Highway Department
1 Front Street
Milford, Massachusetts**

Prepared by:
Massachusetts Department of Public Health
Center for Environmental Health
Emergency Response/Indoor Air Quality Program
July 2005

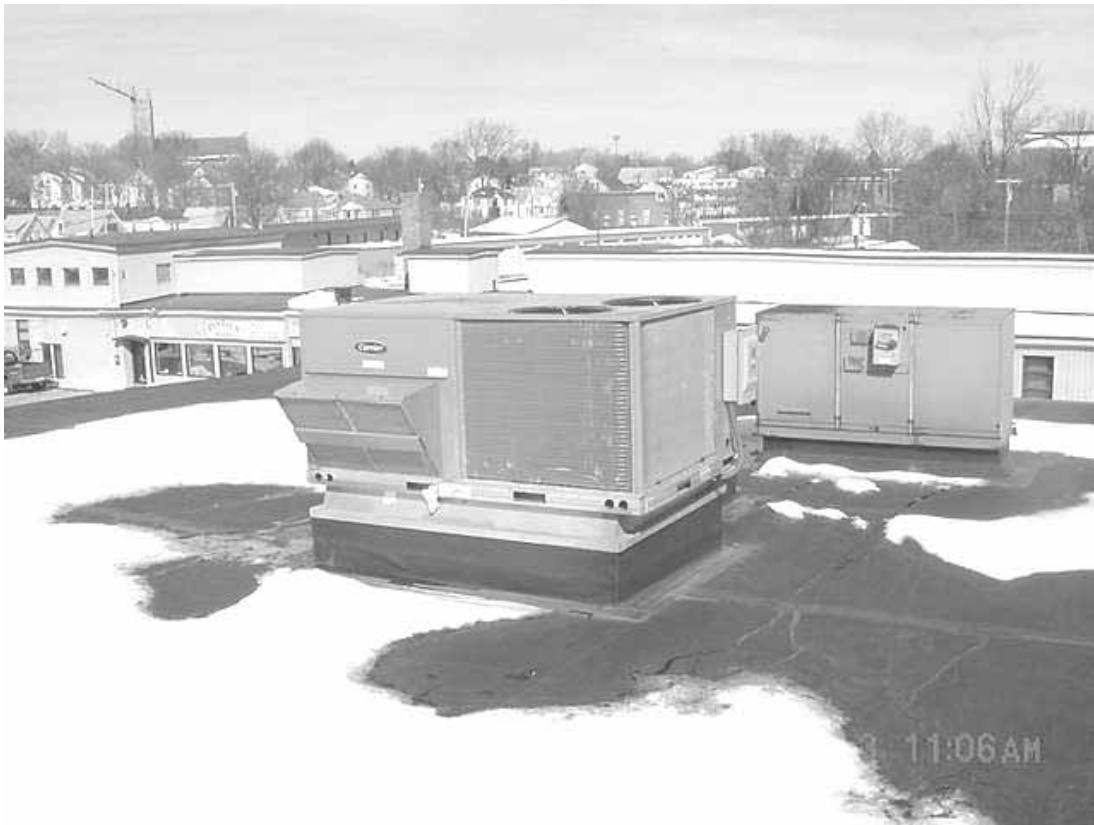
Picture 1

It can be seen from Table 1 that carbon dioxide levels were below 800 parts per million (ppm) parts of air in all areas surveyed, indicating adequate air exchange. Mechanical ventilation is provided by a heating, ventilating and air conditioning (HVAC) system. A rooftop air handling unit (AHU) equipped with high efficiency pleated air filters introduces fresh outdoor air to the building (Pictures 1 and 2). Conditioned outside air is distributed through ducted ceiling vents and returned to the AHUs by ducted ceiling-mounted return vents (Pictures 3 and 4). Thermostats that control the HVAC system have fan settings of “on” and “automatic”. Thermostats were set to the “automatic” setting during the assessment (Picture 5). The automatic setting on the thermostat activates the HVAC system at a preset temperature. Once the preset temperature is reached, the HVAC system is deactivated. Therefore, no mechanical ventilation is provided until the thermostat re-activates the system.

Rooftop Air Handling Unit

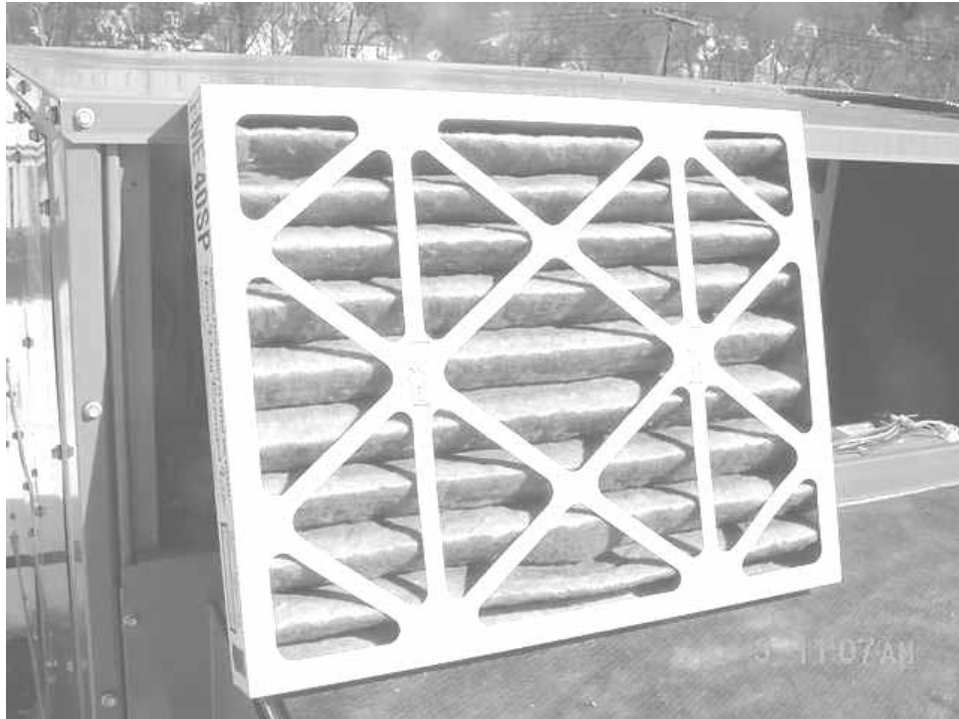
Picture 2

High Efficiency Pleated Air Filters Installed in Air Handling Unit

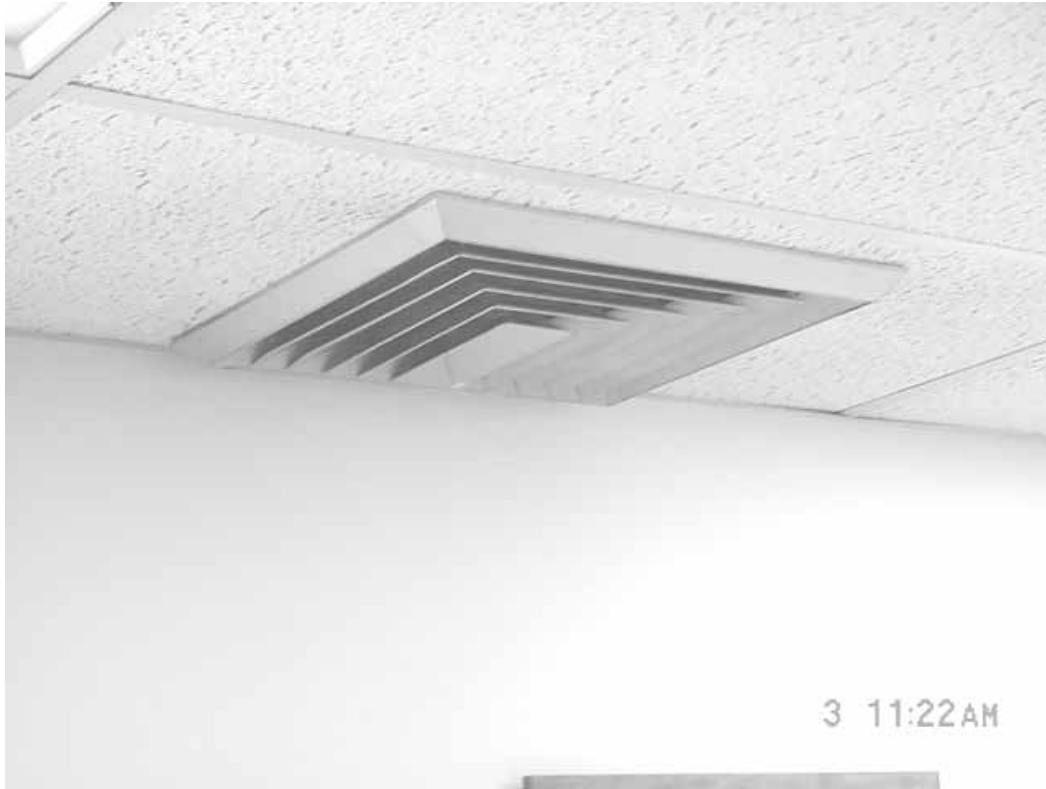
Picture 3

Ceiling-Mounted Supply Air Diffuser

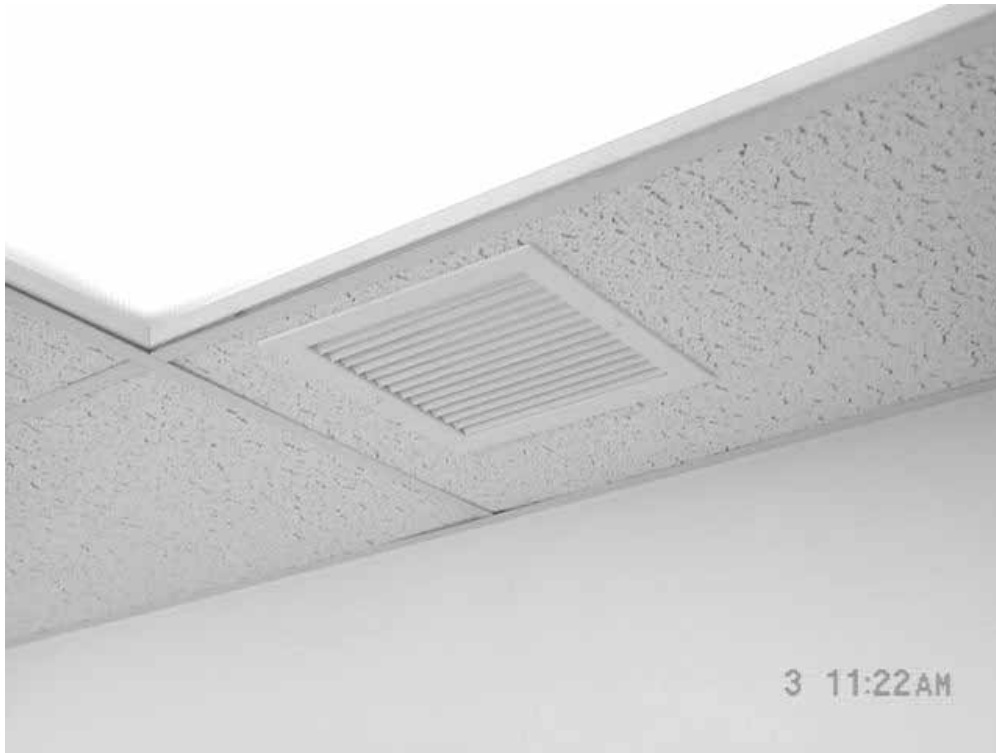
Picture 4

Ceiling-Mounted Return Vent

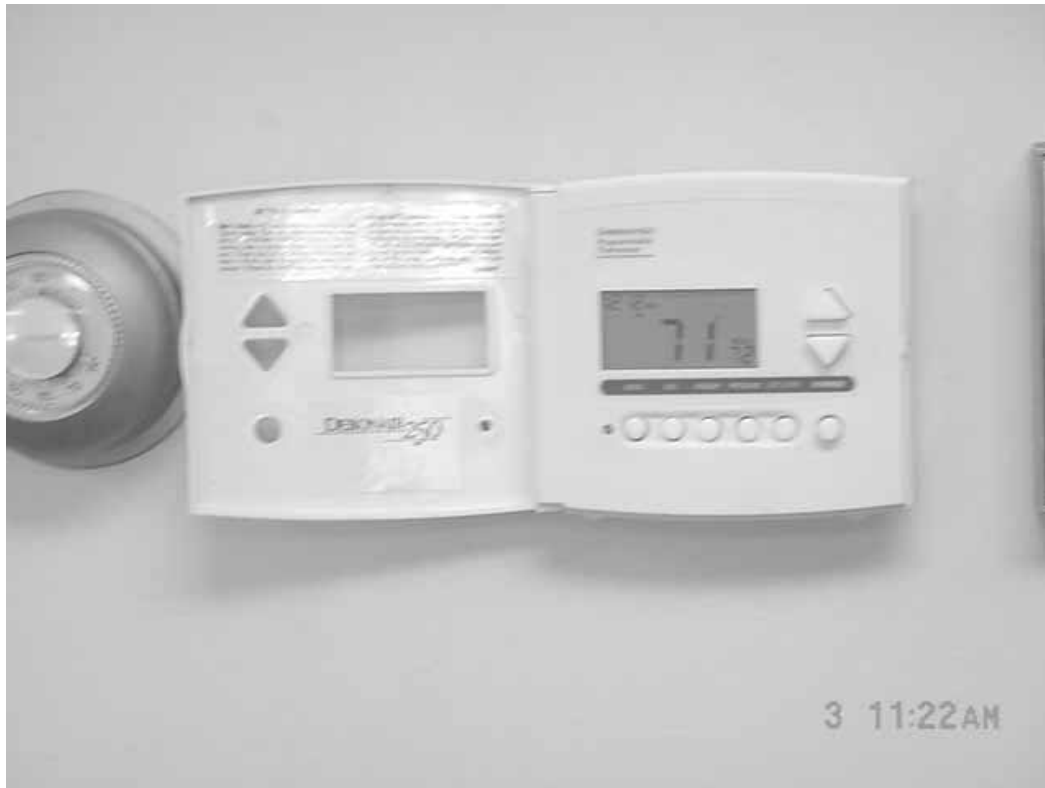
Picture 5

Thermostat for HVAC System With Fan Set to “Auto”

8. Operate both supply and exhaust ventilation continuously during periods of building occupancy independent of thermostat control to maximize air exchange. Consider setting thermostat controls to the "on" position to provide constant supply and exhaust ventilation.

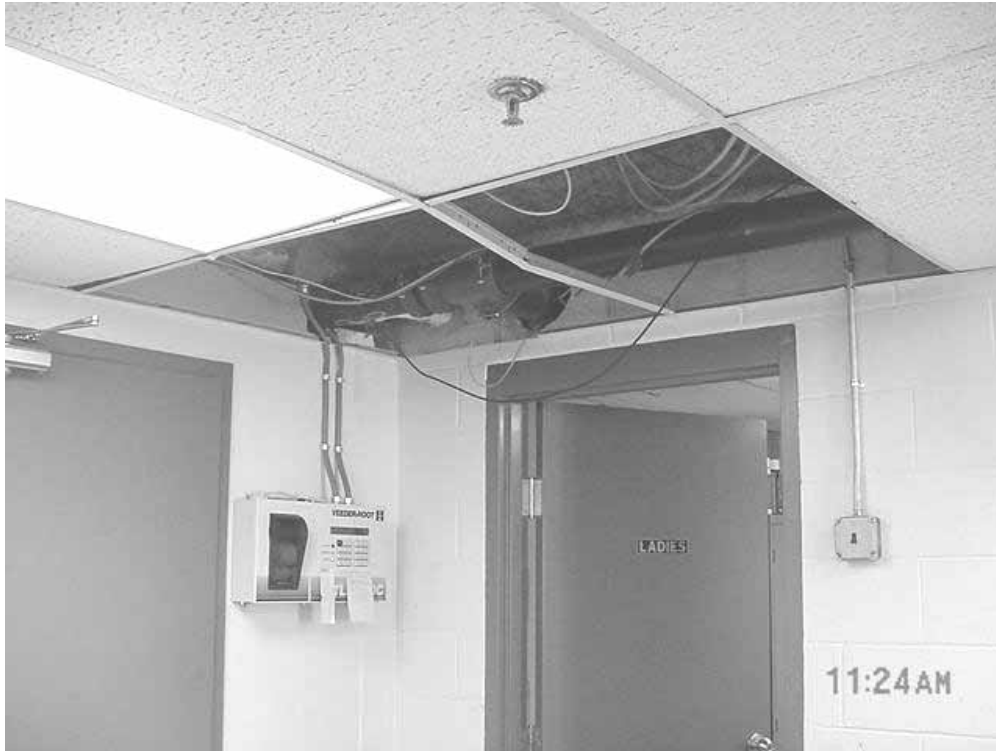
Picture 6

A number of areas had water-stained, missing or damaged ceiling tiles (Picture 6). Occupants reported that ceiling tiles became damaged as a result of leaks from the sprinkler system that have since been repaired. Active roof leaks were also reported; MHD officials were reportedly working with a roofing contractor to identify and repair these leaks. Water-damaged ceiling tiles can provide a source for mold growth and

should be replaced after a moisture source or leak is discovered and repaired. Missing and/or damaged tiles can provide a means for dust and particulates that accumulate in the ceiling plenum to move to occupied areas.

Missing Ceiling Tiles Due to Plumbing Leak

11. Ensure roof leaks are repaired. Repair/replace any remaining water-stained, missing or damaged ceiling tiles. Examine areas above these tiles for microbial growth. Disinfect with an appropriate antimicrobial where necessary.
12. Seal spaces around sink to prevent water-damage to the interior of cabinets and adjacent wallboard. Inspect wallboard for water-damage and mold/mildew growth, repair/replace as necessary. Disinfect areas of microbial growth with an appropriate antimicrobial as needed. Consider replacing with a one-piece, molded countertop.
13. Repair/replace restroom exhaust motors.
14. Refer to resource manuals and other related indoor air quality documents for further building-wide evaluations and advice on maintaining public buildings.

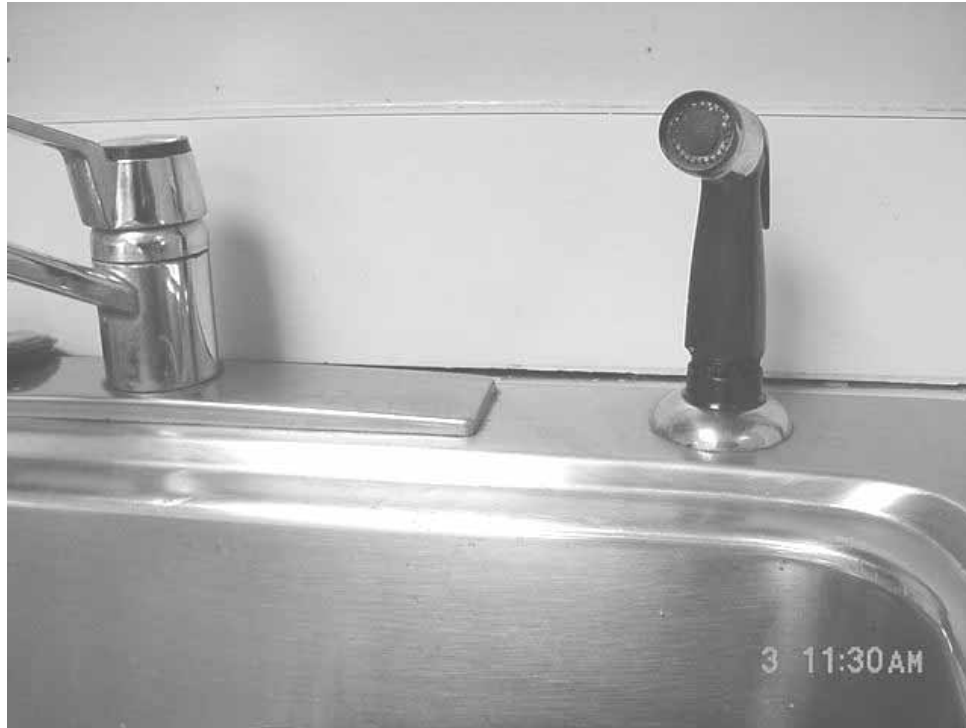
Picture 7

Spaces between the sink countertop and backsplash were noted in the kitchen (Picture 7). Improper drainage or sink overflow can lead to water penetration. If the seam is not watertight, water can penetrate and collect behind the countertop or within cabinets. Like other porous materials, if these materials become wet repeatedly they can provide a medium for mold growth. The US Environmental Protection Agency (US EPA) and the American Conference of Governmental Industrial Hygienists (ACGIH) recommend that porous materials be dried with fans and heating within 24 to 48 hours of becoming wet (US EPA, 2001; ACGIH, 1989). If porous materials are not dried within this time frame, mold growth may occur.

Spaces Between Backsplash and Sink Countertop

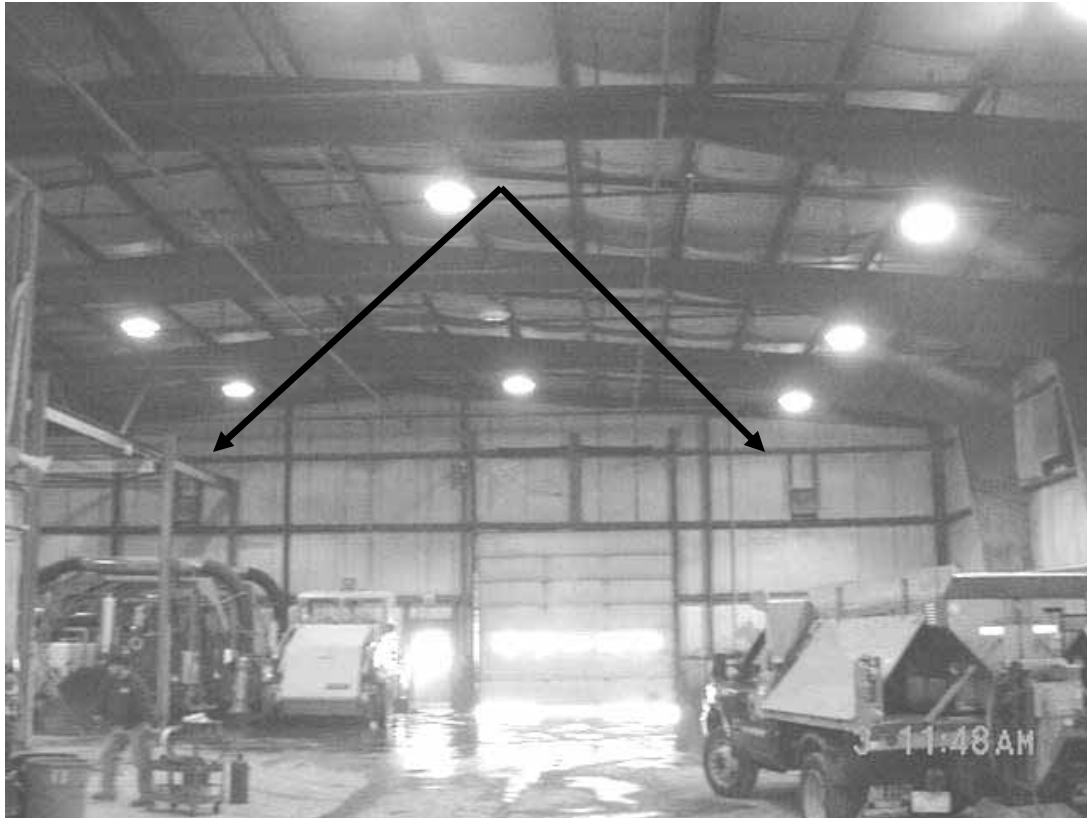
Picture 8

As mentioned previously, the MHD is equipped with a mechanical exhaust system to remove exhaust emissions and other pollutants from the building. The local exhaust system in the garage consists of two large exhaust vents located at the front of the engine bay (Pictures 8 and 9). Four make up air vents are installed on the southwest wall of the garage (Picture 10) to pressurize the engine bay toward the exhaust vent. The automatic activation of this system appears to be dependent on the triggering of carbon monoxide chemical sensors (Pictures 11 and 12). Once a pre-set reading is exceeded, the local exhaust system is activated to introduce fresh air and remove exhaust emissions. Therefore, no mechanical exhaust ventilation is provided until the set-point is exceeded to activate the system. This type of chemical sensor

Interior View of Garage, Arrows Indicate Two Exhaust Vents

1. Continue to operate the garage vent system with manual timer. Consider installing an automatic control to activate the exhaust system as garage doors open.
2. Contact the manufacture and/or installer regarding the operation and calibration of the of the chemical sensor/local exhaust ventilation system. Maintain and calibrate it in accordance with the manufacturer's instructions.
3. Contact an HVAC engineering firm for possible solutions (e.g., roof) for providing outside make up air for the mechanic's bay. Continue to operate local exhaust system in mechanics' bay during hours of occupation. Due to the type of materials used (e.g., solvents, paints, fuels), consider installing an automatic timer to operate the system continuously during occupied hours.
4. Keep all doors accessing the garage and mechanics' bay closed at all times.

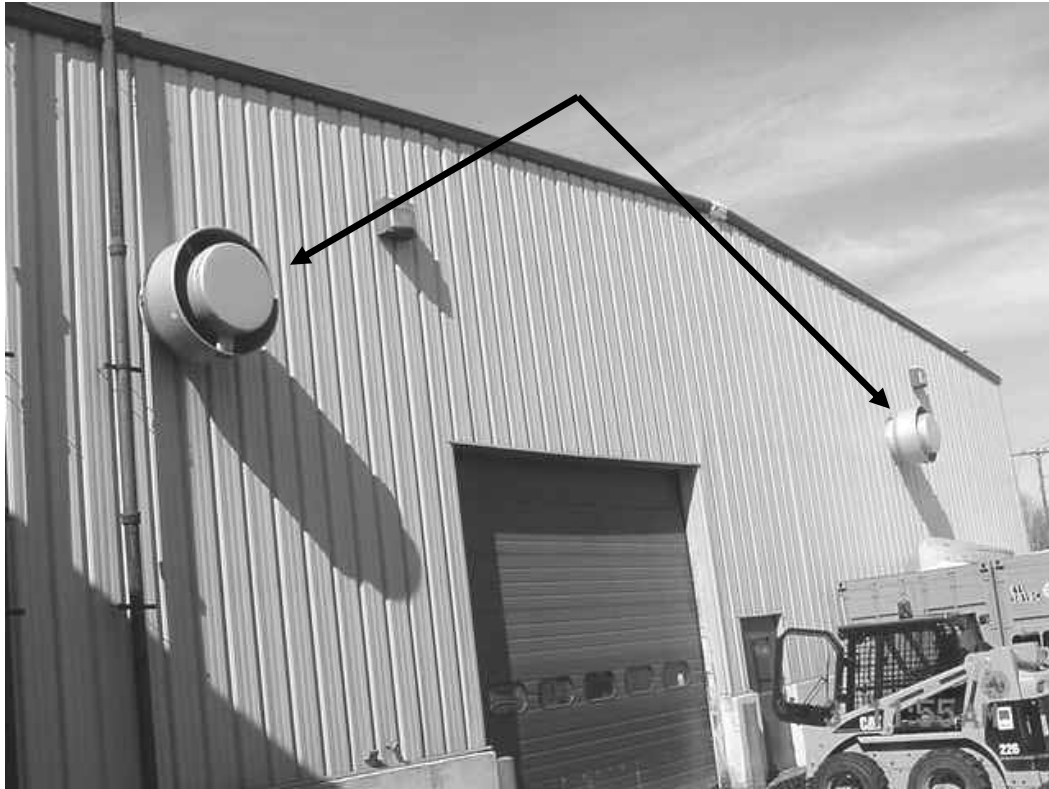
Picture 9

Exterior View of Garage, Arrows Indicate Two Exhaust Vents

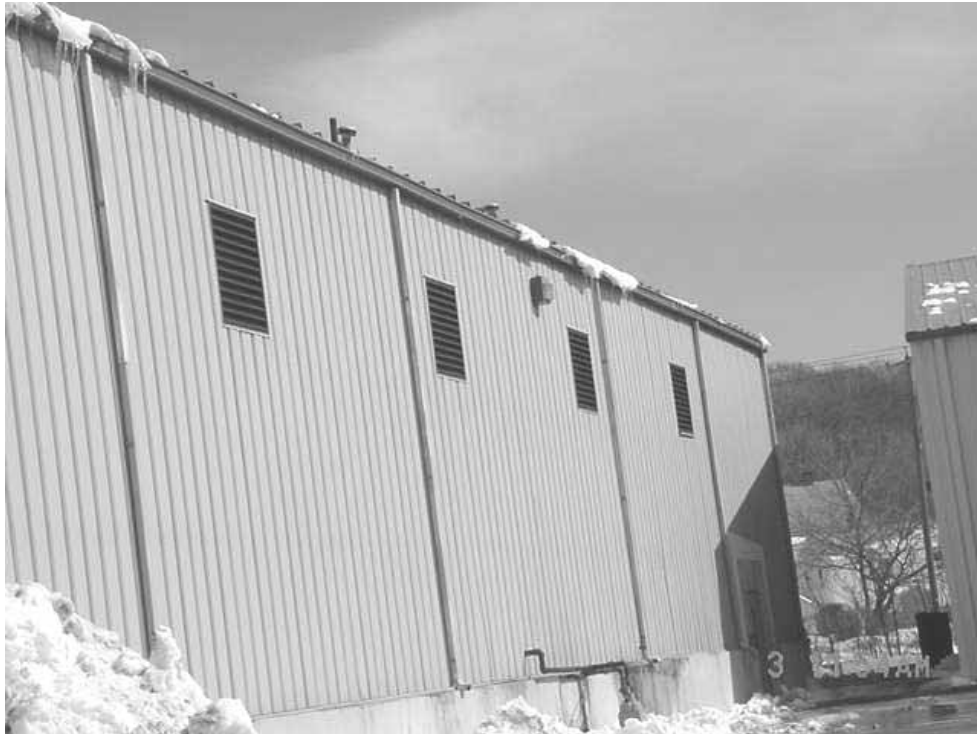
Picture 10

Exterior View of Four Make-Up Air Vents for Garage

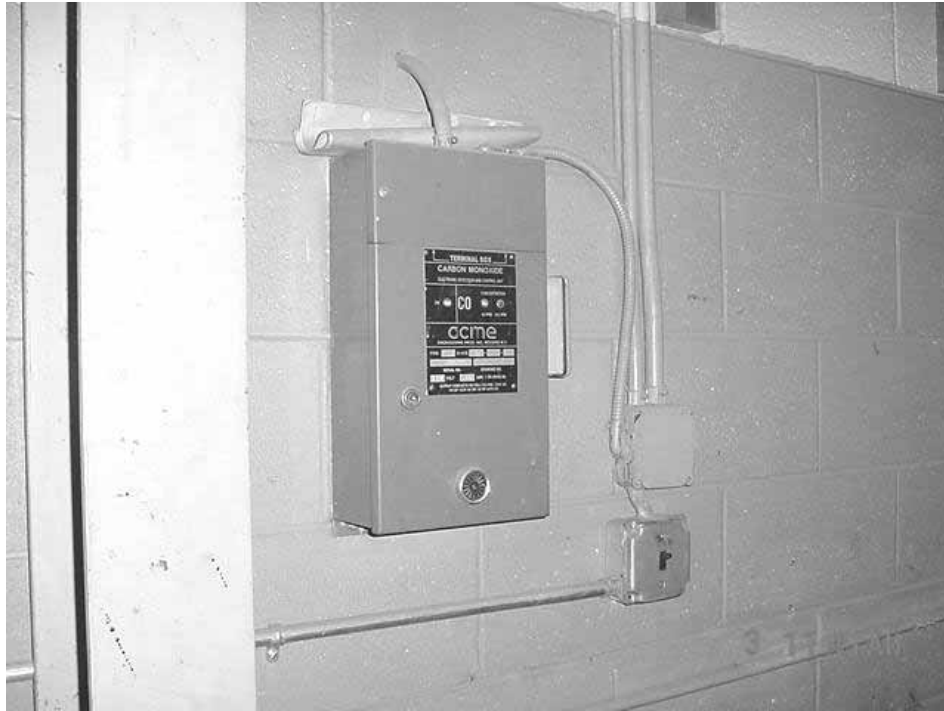
Picture 11

activated system is dependant on accurate measurements of airborne contaminants. MHD personnel could not identify the last time the system was serviced and/or calibrated. MHD staff did, however, report that the system could be manually overridden and that it is activated *as needed* using a wall switch.

Wall-Mounted Carbon Monoxide Sensor Terminal Box in Garage

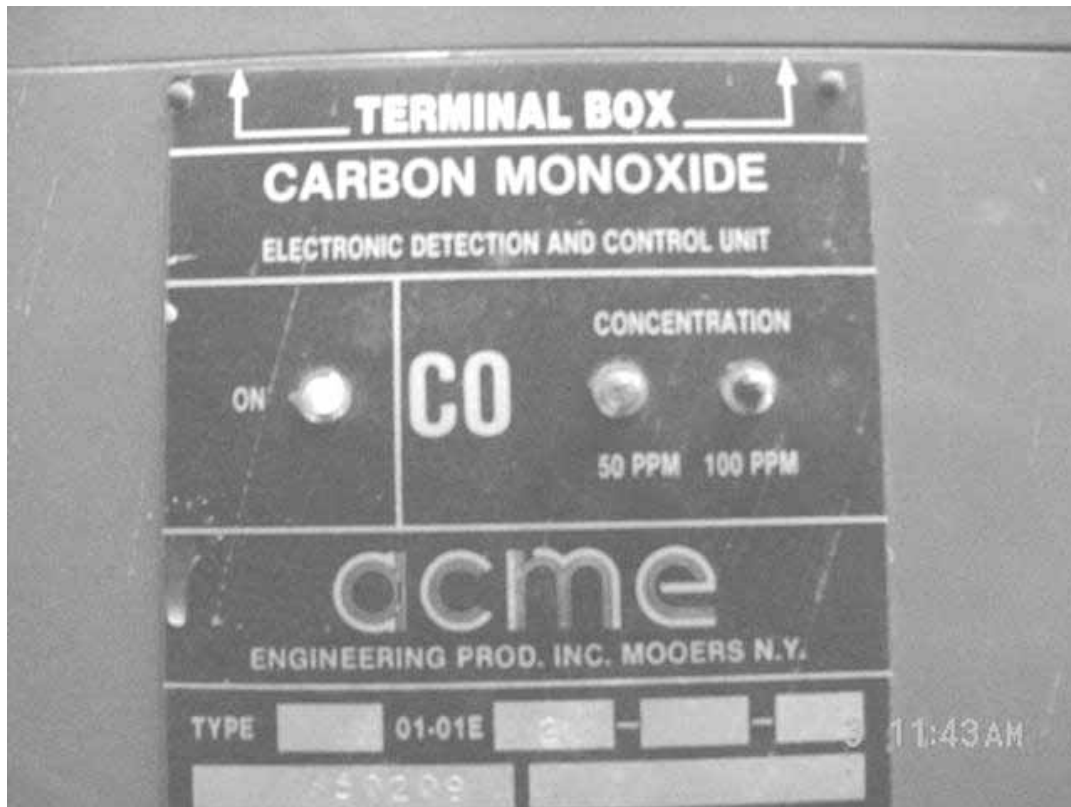
Picture 12

**Close-up of Wall-Mounted Carbon Monoxide Sensor Terminal Box in Garage,
Note Concentration Indicator Lights of 50/100 parts per million (ppm)**

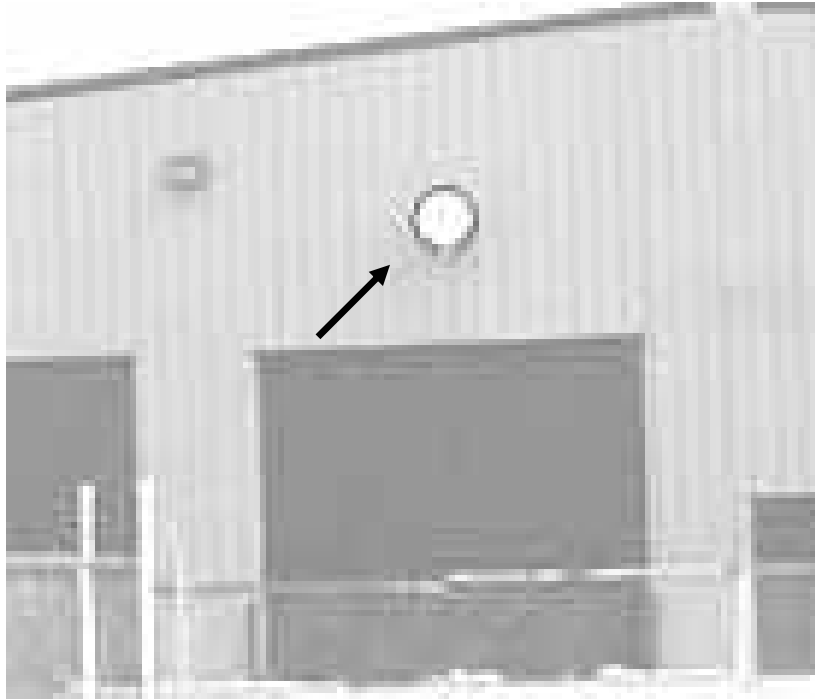
Picture 13

The mechanical exhaust system in the mechanics bay also consists of a large exhaust fan on the exterior wall (Picture 13); however, unlike the garage; there are no outdoor air make-up vents. Instead, a passive vent is installed in the common wall between the mechanics bay and garage to provide make up air (Picture 14). Drawing air from the garage instead of from the outside can also draw-in airborne pollutants present in the garage (e.g., vehicle exhaust). In addition, drawing air from the garage can also compete with and reduce the effectiveness of the local exhaust system in the garage.

Exhaust Motor for Mechanics' Bay

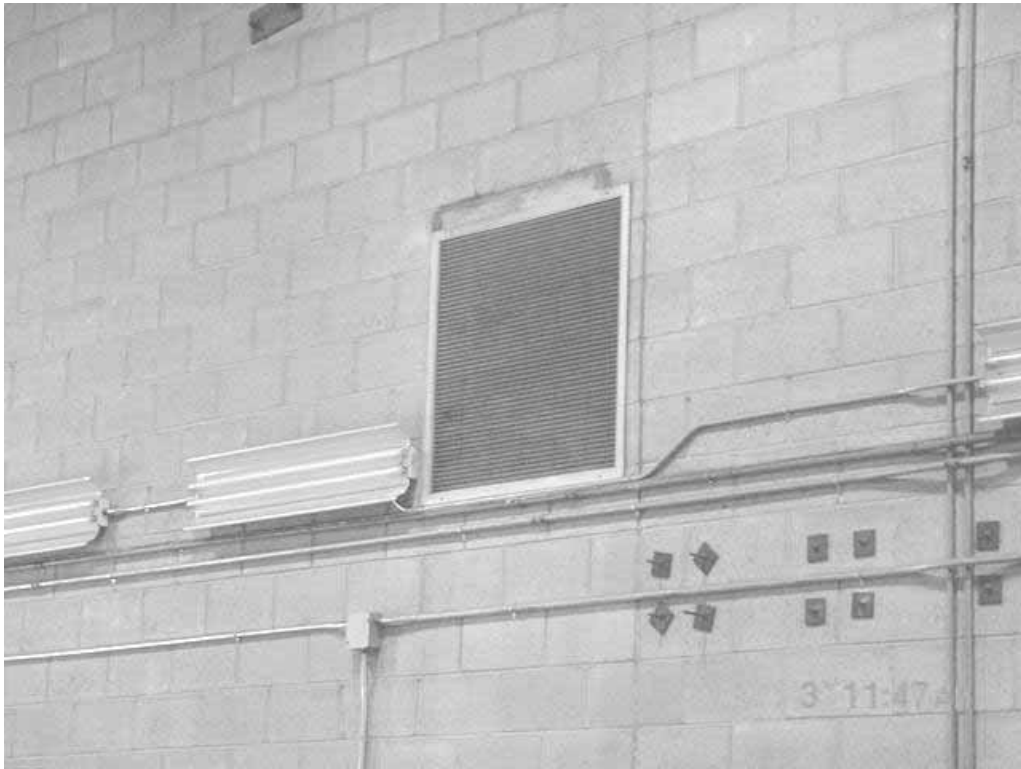
Picture 14

Passive Vent in Common Wall between Mechanics' Bay and Garage

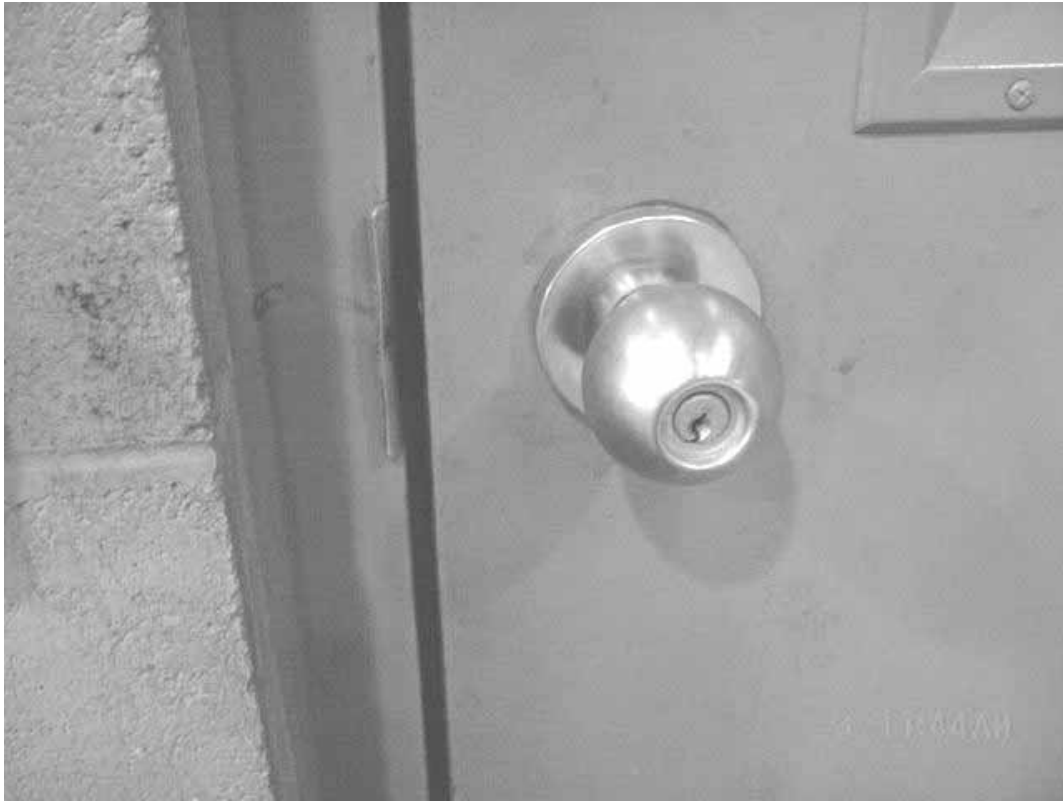
Picture 15

Several potential pathways for exhaust emissions and other pollutants to migrate into occupied areas were identified. The doors to the garage and mechanics' bay had spaces beneath the door where light could be seen penetrating. The door to the mechanics bay also did not close completely (Picture 15). The ceiling/walls of the garage and mechanics bay are penetrated by holes for utilities. If they are not airtight, these holes can be potential pathways for particles to migrate into occupied areas. Each of these conditions presents a pathway for air to move from the garage and mechanics' bay to adjacent areas. In order to explain how these pollutants may be impacting adjacent areas, the following concepts concerning heated air and creation of air movement must be understood.

Spaces around Door to Mechanics' Bay that Does not close Properly

5. Ensure doors around the garage and mechanics' bay fit completely flush with threshold. Seal doors on all sides with foam tape, and/or weather-stripping. Consider installing weather-stripping/door sweeps on both sides of doors with access to the engine bay to provide a dual barrier. Ensure tightness of doors by monitoring for light penetration and drafts around doorframes.

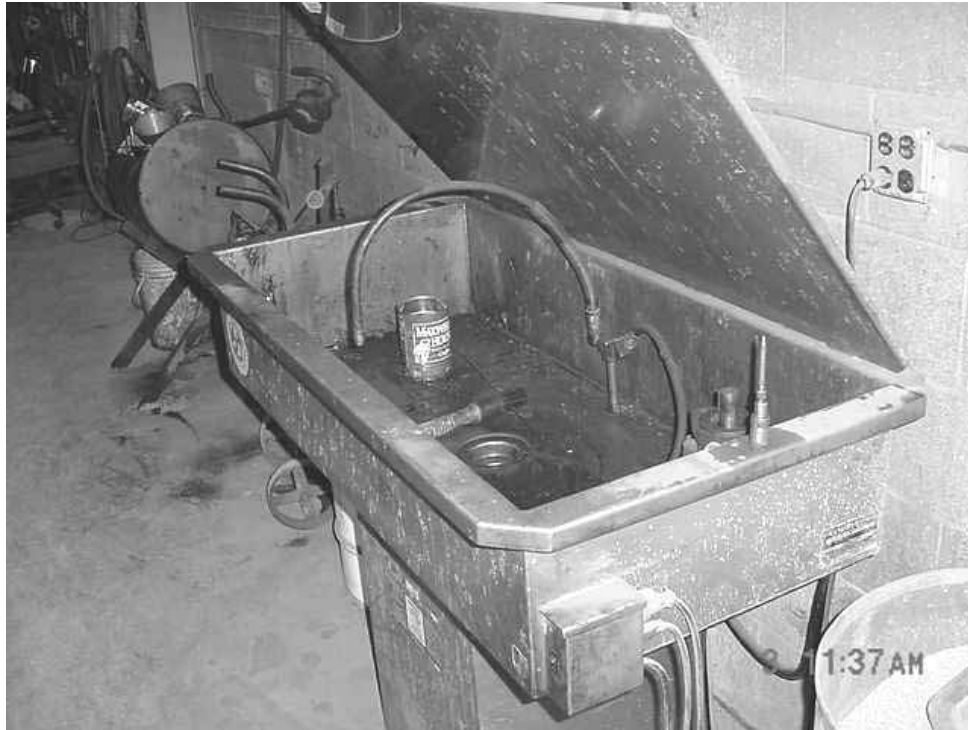
Picture 16

were spray-painting. The level of TVOCs was reduced to 1.0 ppm within 5 minutes via the local exhaust system (Table 1). A parts washer containing solvents and open containers of oil were also observed in the mechanics' bay, which can contribute to the off-gassing of TVOCs (Pictures 16 and 17).

Parts Washer in Mechanics' Bay

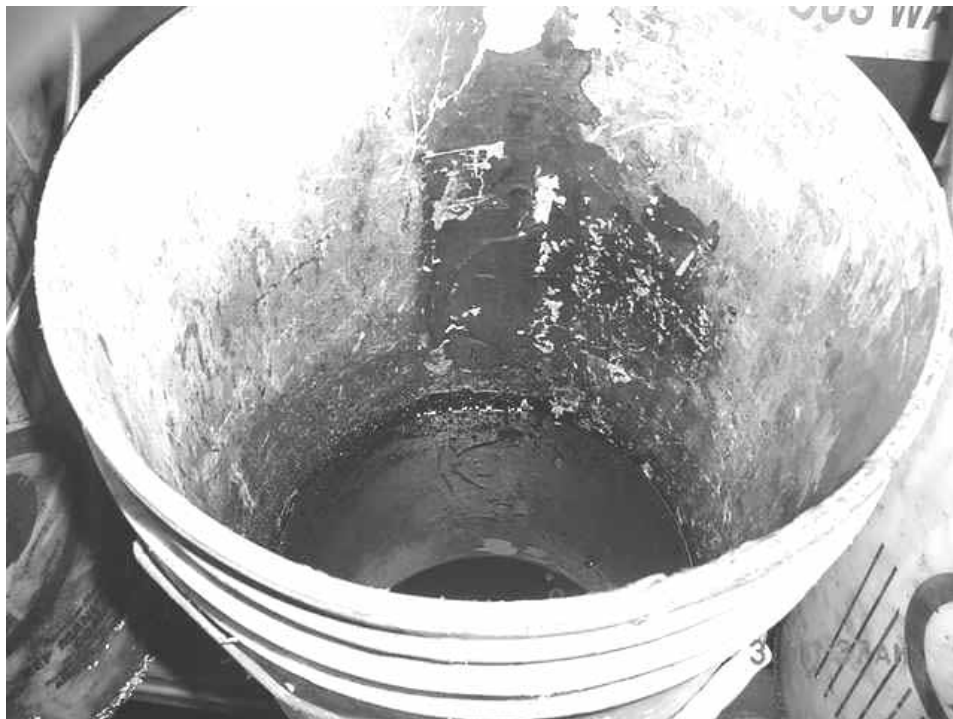
Picture 17

Container with Motor Oil in Mechanics' Bay
